## TEXTILE MILLS can SAVE UP TO 6 % ENERGY SAVINGS now in their RING FRAME TIN ROLLER BEARINGS.

Ashok.S / BEE Accredited Energy Auditor, Coimbatore, India. Mail to :-[ashok@energymeasuretosave.com](mailto:ashok@energymeasuretosave.com)

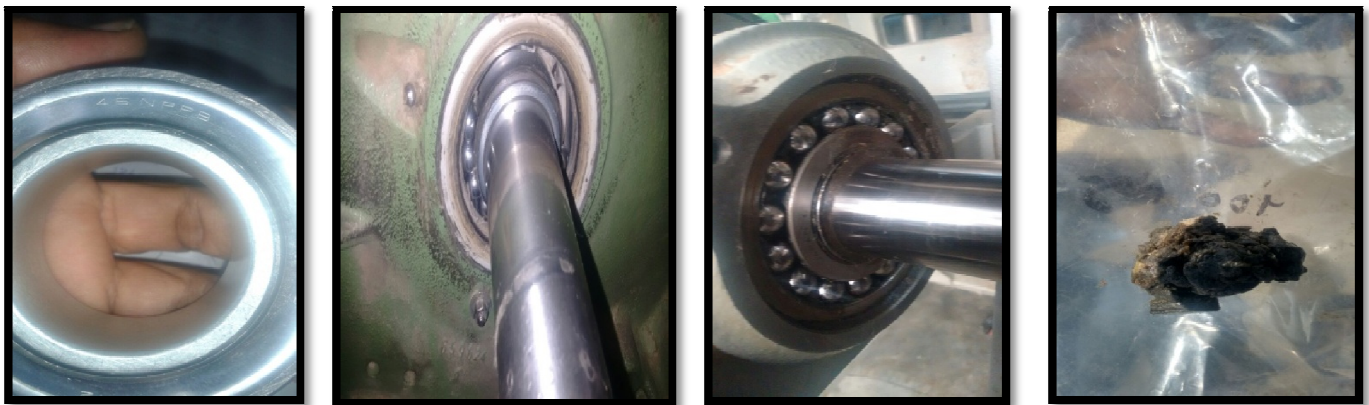
45 NPPB Tin roller Bearing / Tin Roller Bearings seen after removing grease hard cake / Grease Hard cake (see Hand below!!)  
Result of Repeated pumping in Re-greasing of MP3 grease / Images & Inputs – Courtesy: Salona Cotspin Ltd, Coimbatore.

17. Check and take image of bearings with hard lumps of grease cake sticking on, and this is due to oil in grease dried out early
18. **Not only, in tin roller bearings, but also in all higher HP motor bearings, this Specialty grease to apply Today & Now.**

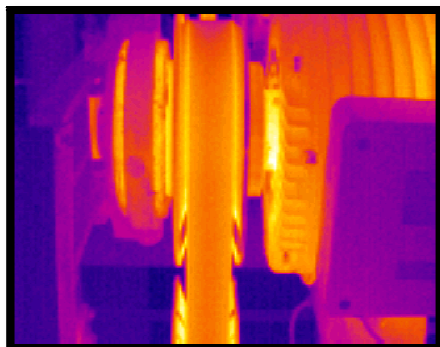
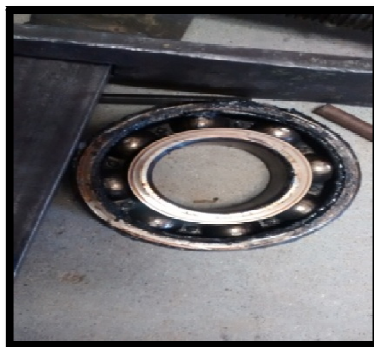
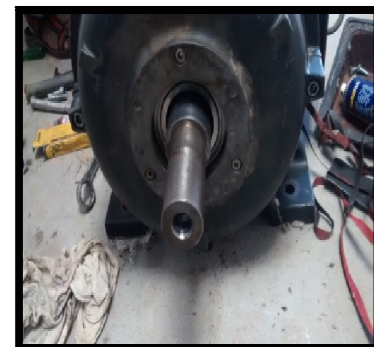
**Motor OEM BALDOR gives longer time interval for re-greasing with Polyurea grease / MP 3 grease Dried on motor Bearings.**

19. **Motor Manufacturer BALDOR puts this grease** on his motor & gives longer re-greasing interval under severe conditions.
20. When this suits hot motor bearing for better shear resistance and grease consistency, this will suit well for tin roller' too.
