Thermography based Predictive Energy Management practices.

- Energy Auditing Practices using the Thermal Imager in the industry areas, especially in the Electrical Prime Mover Systems in the field, Process flow trains in the Production and utility,
- Machine condition monitoring as a System.
- Energy & Raw Material given in the Input
- And energy & product delivered in the output
- & Energy & Material in Exhaust, wasted areas

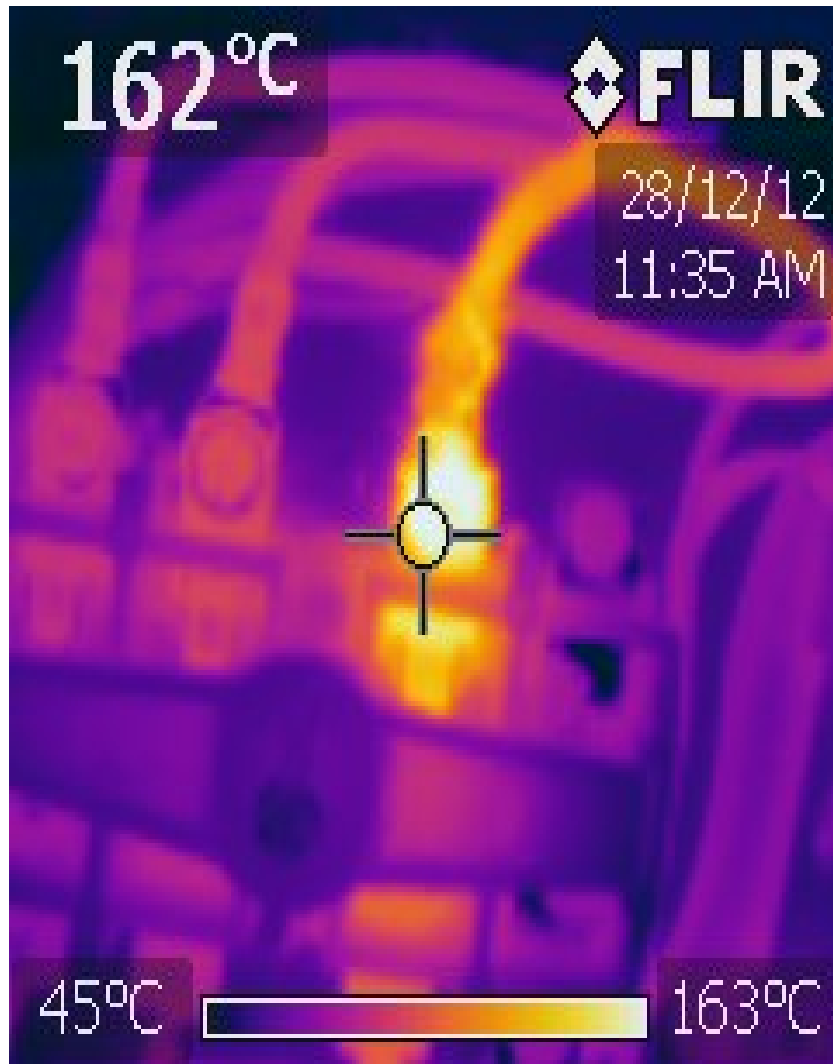
**Motor to fail, shortly due to single phasing.
Loose connection in Bus bar leads to volt and
current unbalance and efficiency drops.**

Voltage unbalance increases, motor loss increases

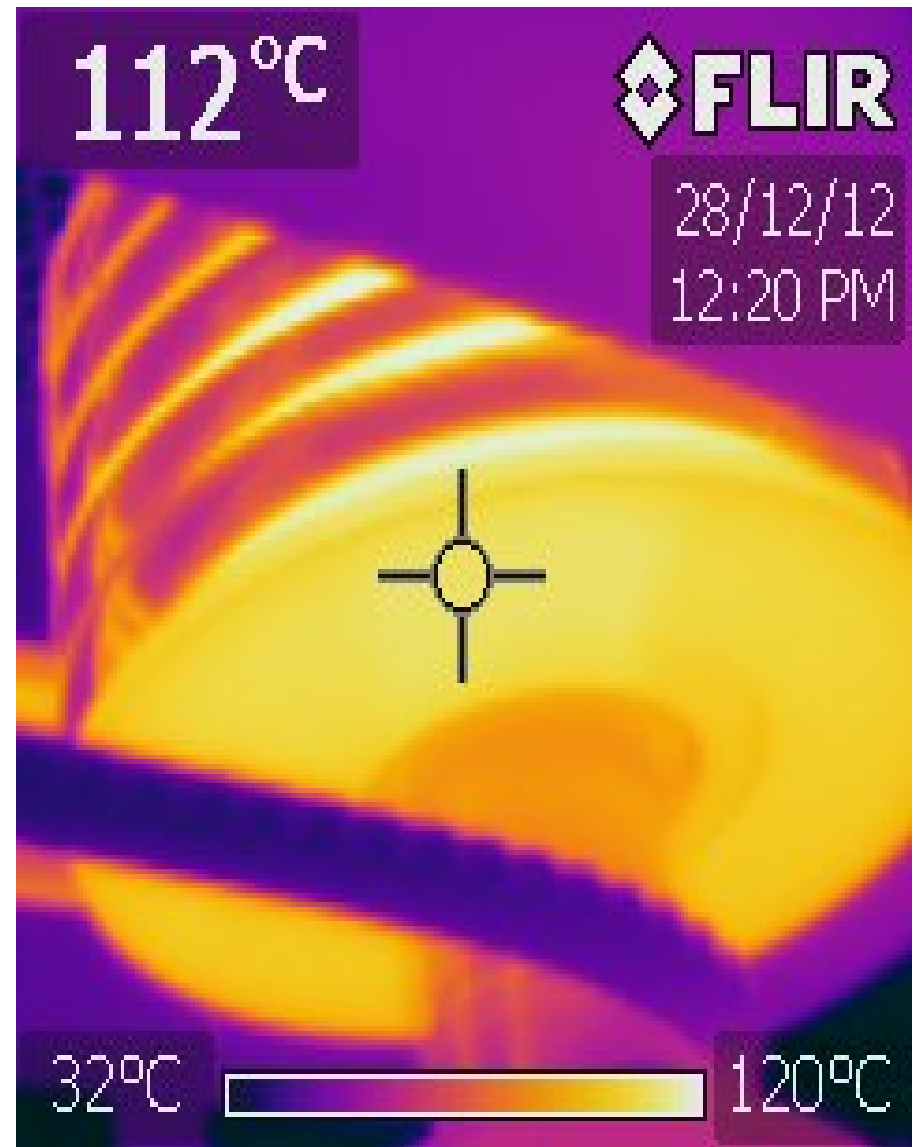
Motor belt & pulley hotter than motor drive end.

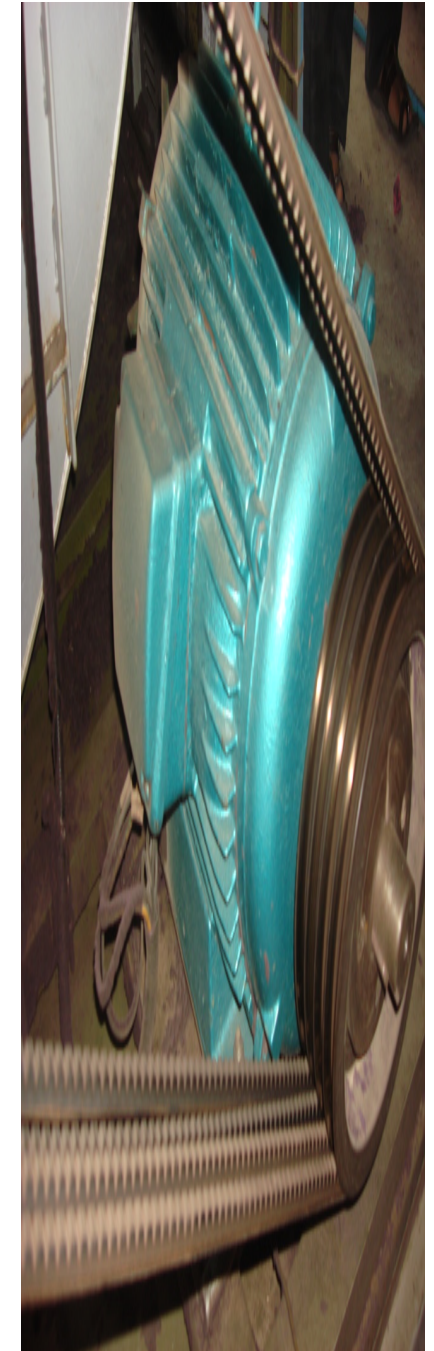
**Motor hotter due to poor ventilation.
Motor central skin hotter due to more
rewindings done and less efficiency now.**

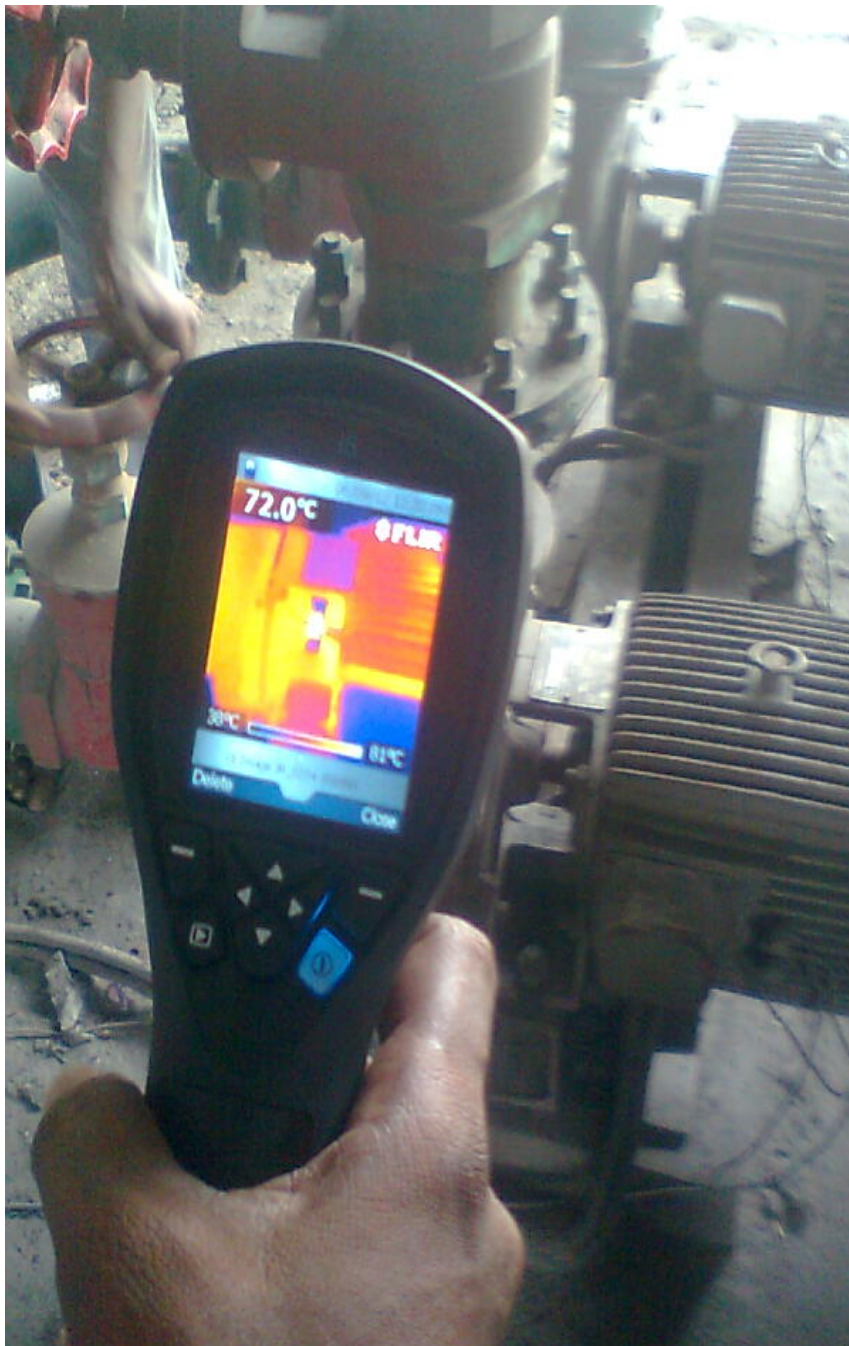
Hot spots motor bearing DE & NDE

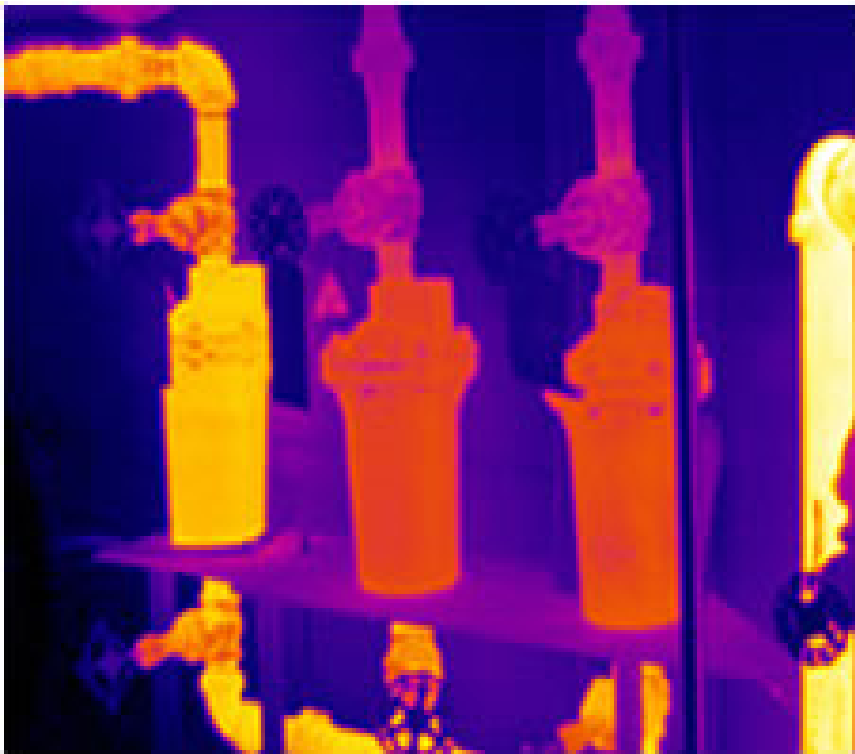
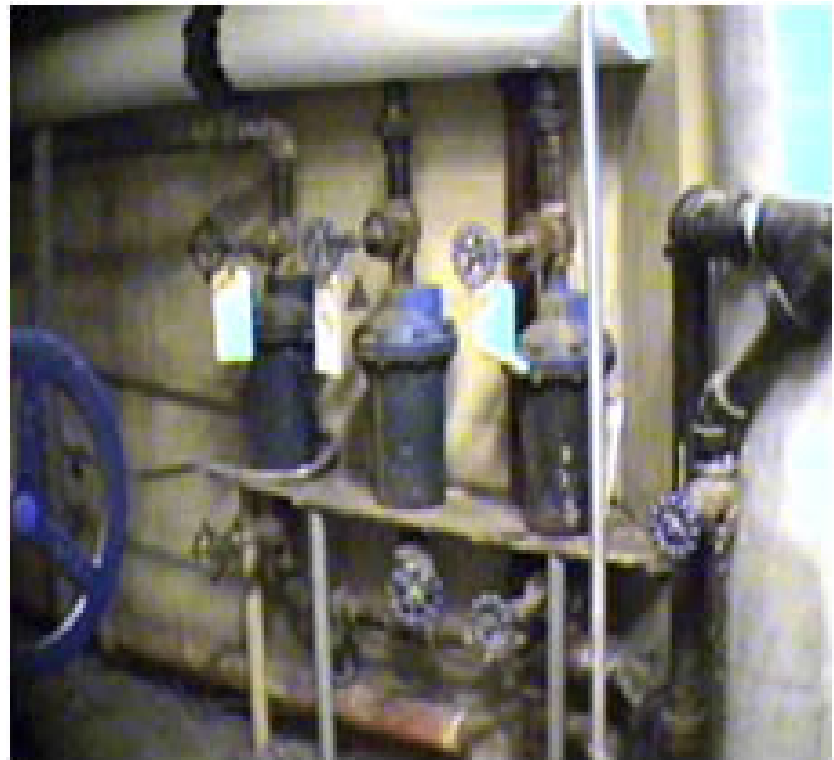
Steam Trap Thermal Imaging points to :-

In these two photos of steam traps, the Infrared Thermal Imaging photo on the left shows the point of leakage.

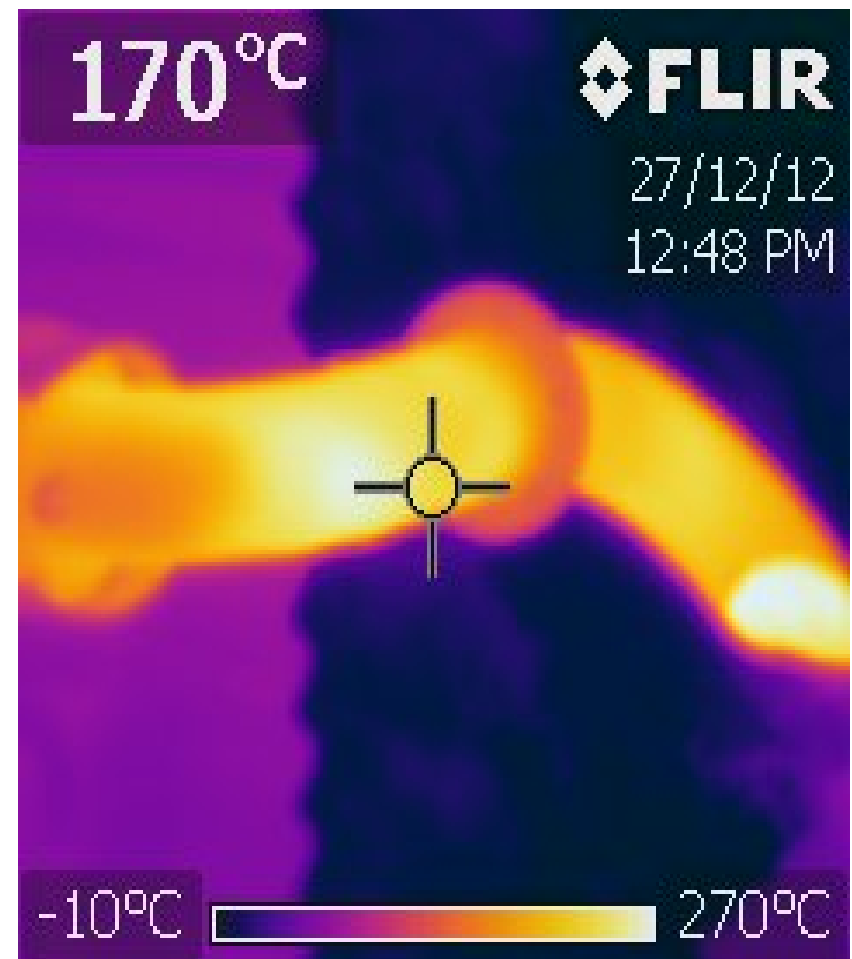
**DG sets getting de-rated due to choked exhaust
DG was overloading before and tripping. After
correction, they could fully utilize DG KVA rating.**

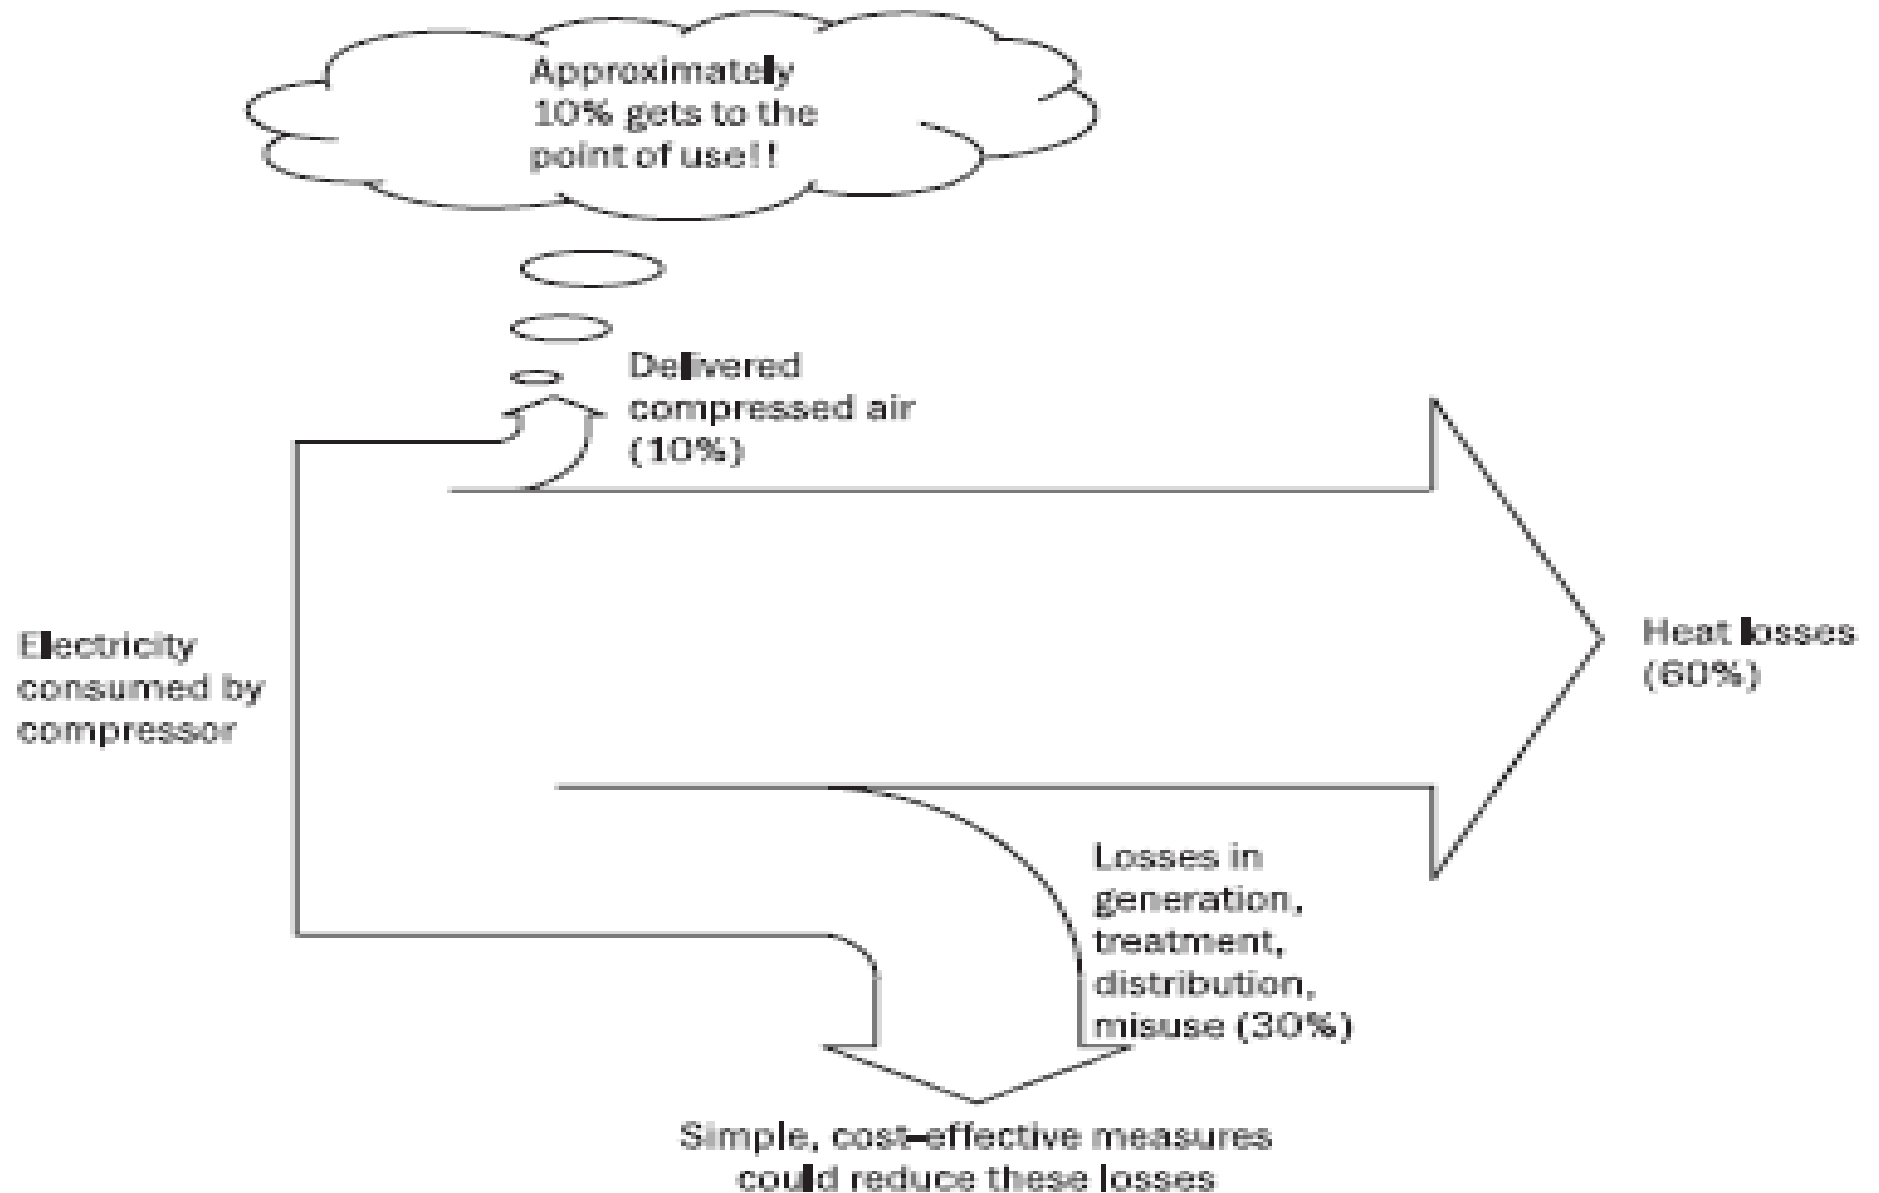
Fraction of compressed air produced only is delivered to machine. Losses in generation, distribution & usage matters.

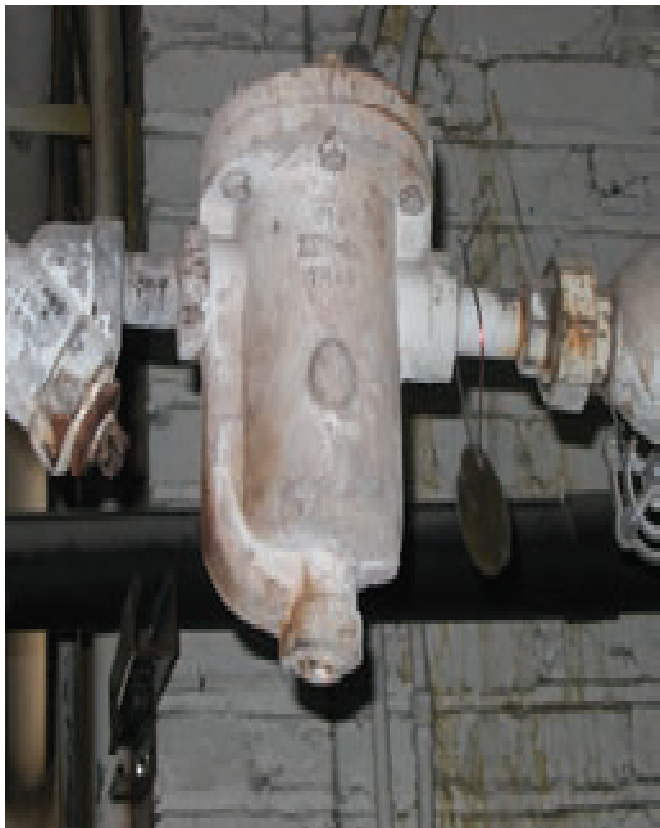
STEAM TRAP – THERMAL IMAGING

When operating correctly, as in this example, steam trap thermal images should show an abrupt change in temperature.
