VISUALIZE VISIBLE LOSSES IN BELTS & PULLEY DRIVES IN YOUR INDUSTRY

By Ashok.S, BEE Accredited Energy Auditor, ashok@energymeasuretosave.com

K.S.Subramanian, Specialist, Belts & Pulley Drives. kss.1966@gmail.com

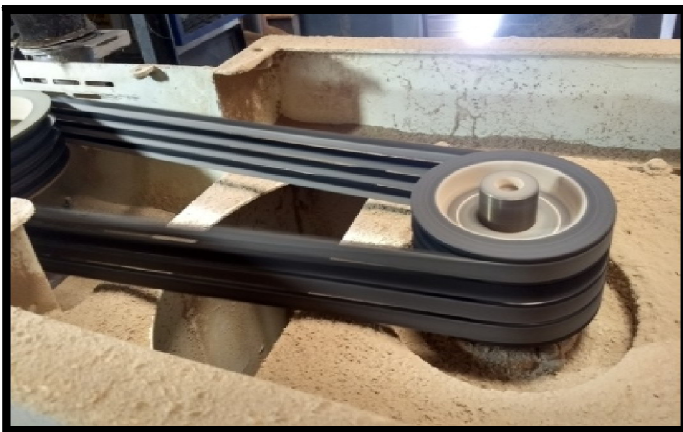
III image shows excess weight in pulley and more number of belts in 30 HP rated Rice Polisher machine.

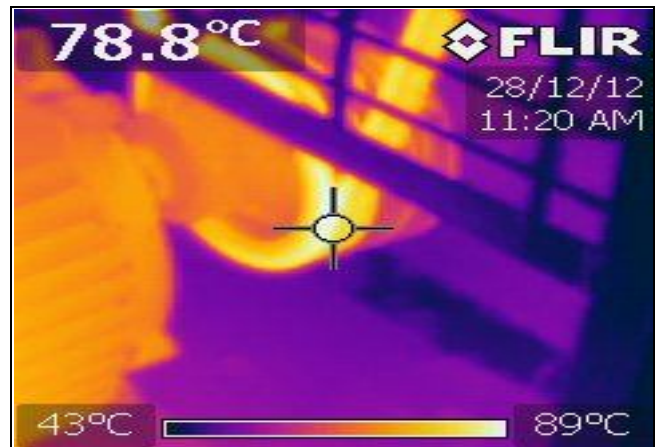
IV image shows the thermal imaging of worn-out pulley due to belt and alignment issues raises temperature to 89 *C. This Thermal Image of belt & pulley will show how much your KW input to motor is unwantedly heating up the belts & pulley drives. You will also find rubber burnt smell and screeching sound when machine is started and these are the signs of wear-out happening.

1. Today, with your Infra red Thermal Imager, scan and screen the hundreds of belt driven motors in your industry. You focus on the motor & machine Drive End bearings, the motor & machine pulleys, and belts end to end.

2. Assuming the ambient of 40*C, the relative temperature increase must not increase above 10*C above the Ambient, when measured at belts and pulleys. Any relative temperature deviation shows the nature of ab-normality in the alignment. After screening, you can concentrate on the hot spots like belts & pulleys. This is apart from bearing checking on motors.

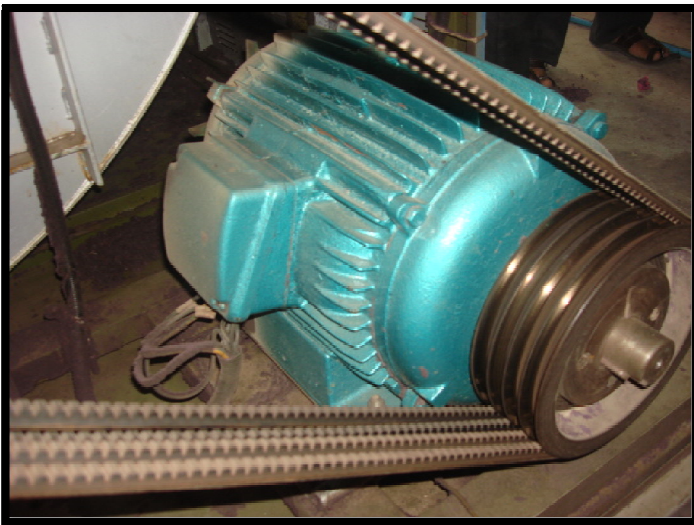
V image – Cogged Belts and Drives rightly changed for this motor drive system and Energy savings achieved.

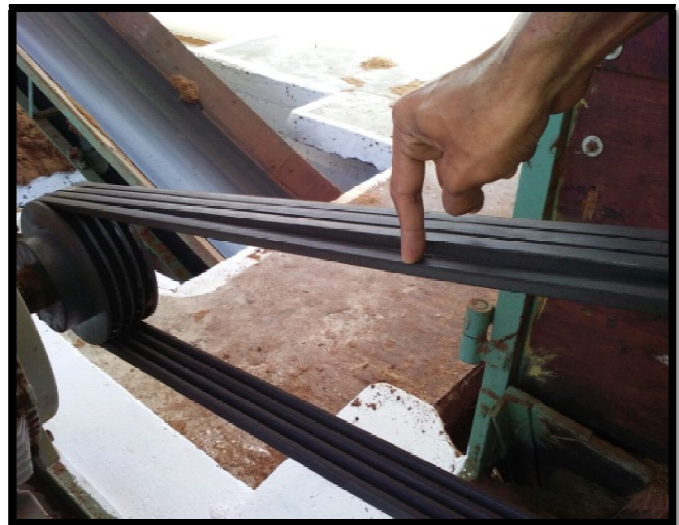
VI image Belt Tension must be in such a way that when pressed, it must not exceed the belt thickness here.

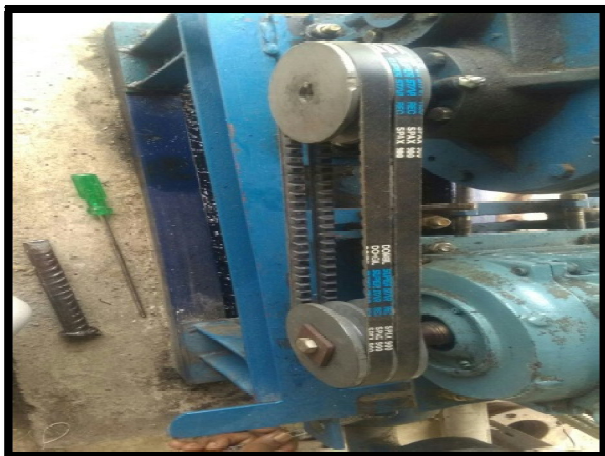
VII image Cogged belting done in this machine, see the right size of belts, pulley sizes and the Angle of Arc contact.

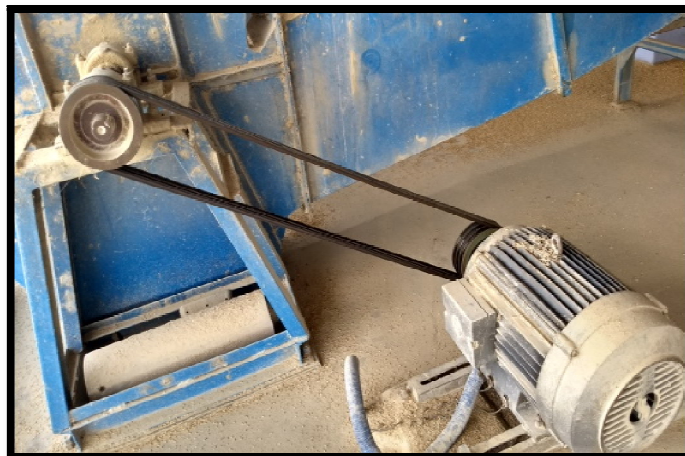
VIII image See the Motor & Load Pulley sizing – cogged belts rightly matched to look in STILL motion in Run mode.

When you view your running machine's belt transmission, the running belt must look STANDSTILL. This is the visual symptom of healthy power transmission from motor to machine, by belt. Actively gripping belts look like Standstill when machine is running. Passively touching belts vibrate more to prompt the losses. If you see wobulations in your belts, this shows the belt transmission efficiency is losing and energy losses due to slippage, mis-alignment of belts, poor matching of belts to drive, hotter Drive-end bearings.
